The Blowhole Viewing Platform, Port Campbell Coast

The Port Campbell Community Group Inc. is deeply concerned at the unsympathetic design and negative environmental impacts of the Blowhole viewing platform, again going ahead without community consultation.

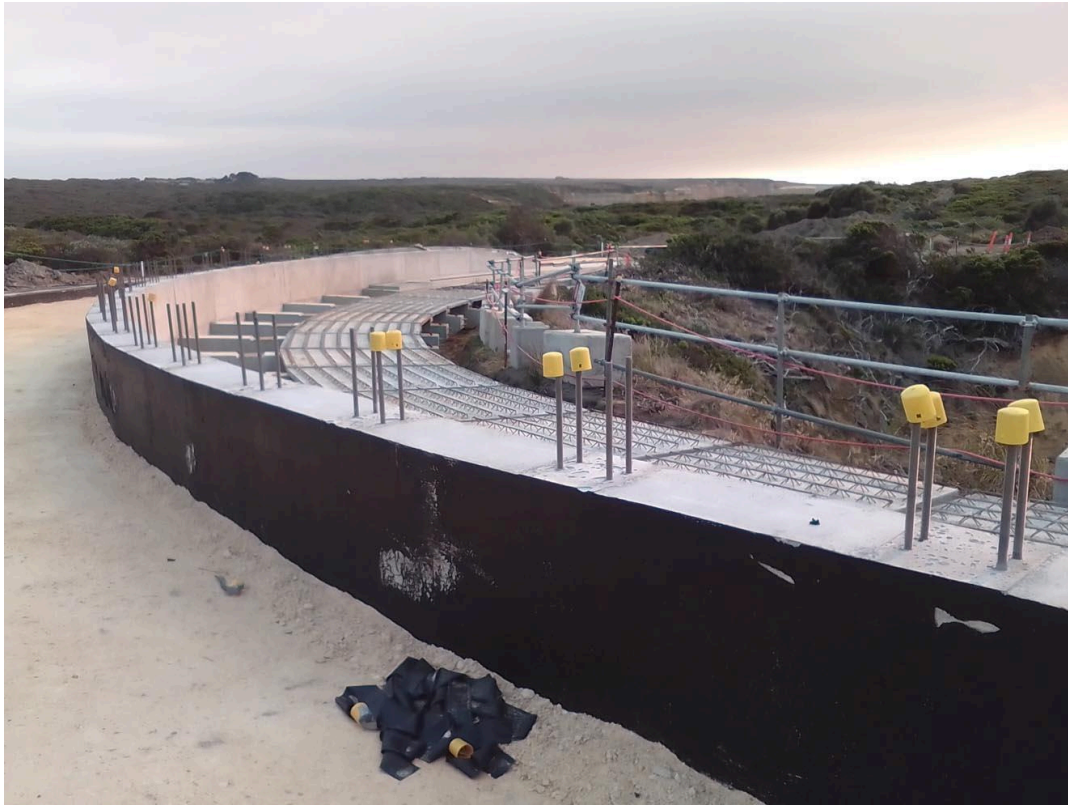
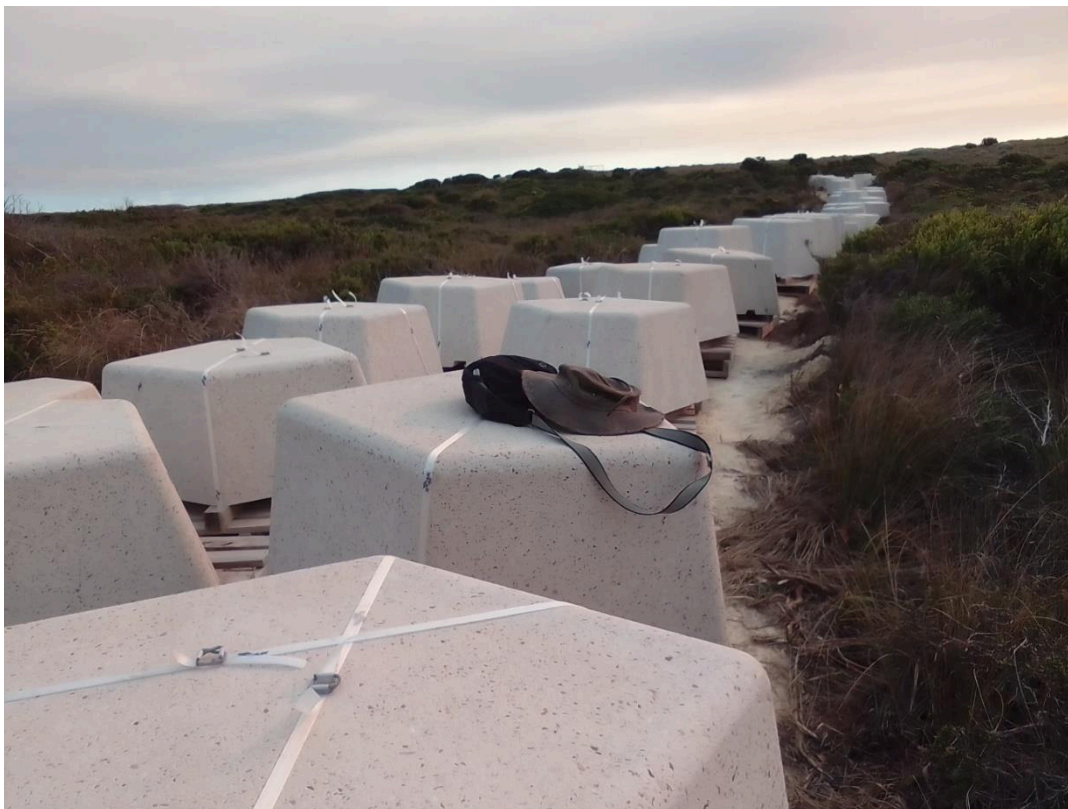
The Community has not been shown how the masses of concrete and new design considers geotechnical issues and the fragile limestone. Photos: 19-12-2024

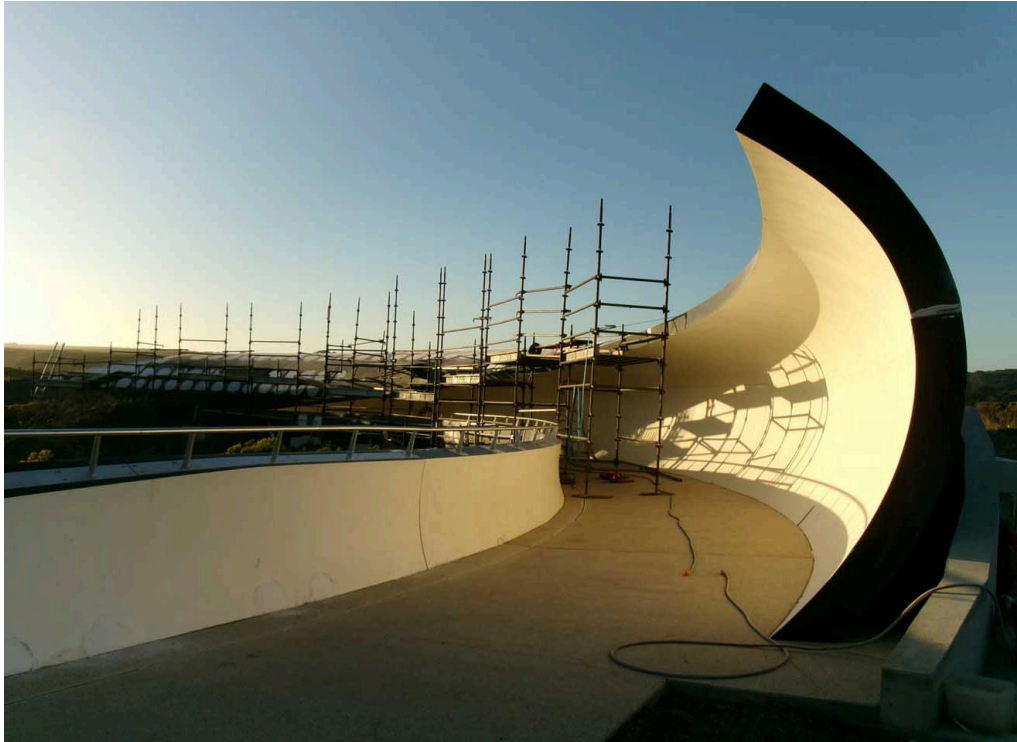
During construction (above)

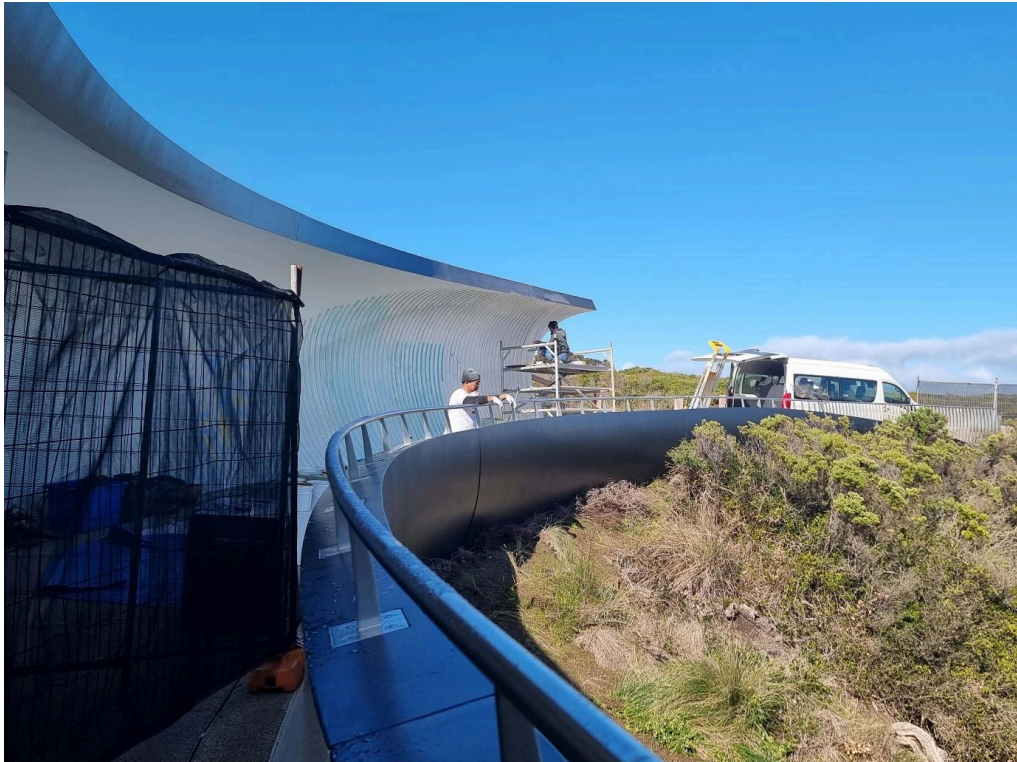
8/8/2025 – Painting out graffiti?

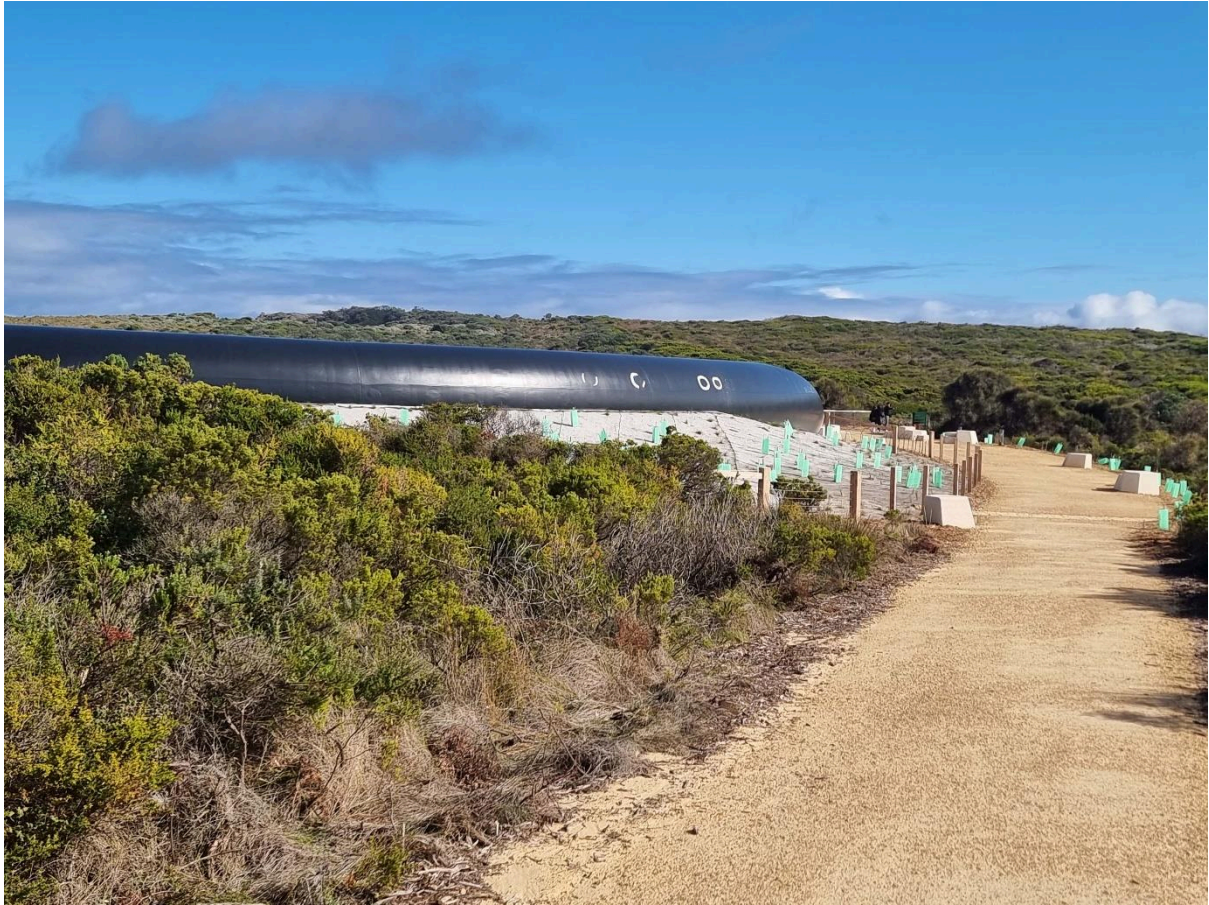
It seems the polycarbonate tube has flexed as the 'portholes' appear to have cracked and are painted in white. 8/8/2025
