This article shows the instability of the cliffs at the 12 Apostles viewing platform, with photos of its construction and the finished result – loads of concrete and deep foundations and aesthetic incompatibility with a sensitive environment.

12 Apostles diving board viewing platform. Photo PCCG Inc. 16-5-2023

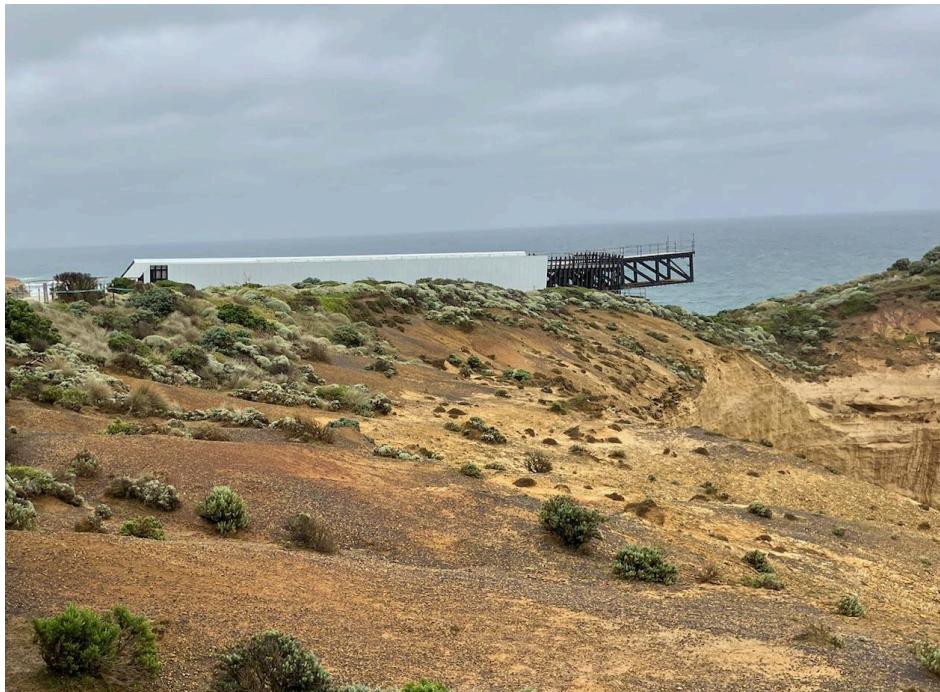
12 Apostles viewing platform 10 Jan 2024. A blight on the landscape - PCCG Inc. The Design is based on the Red-tailed Black cockatoo – which is not indigenous to this coast.

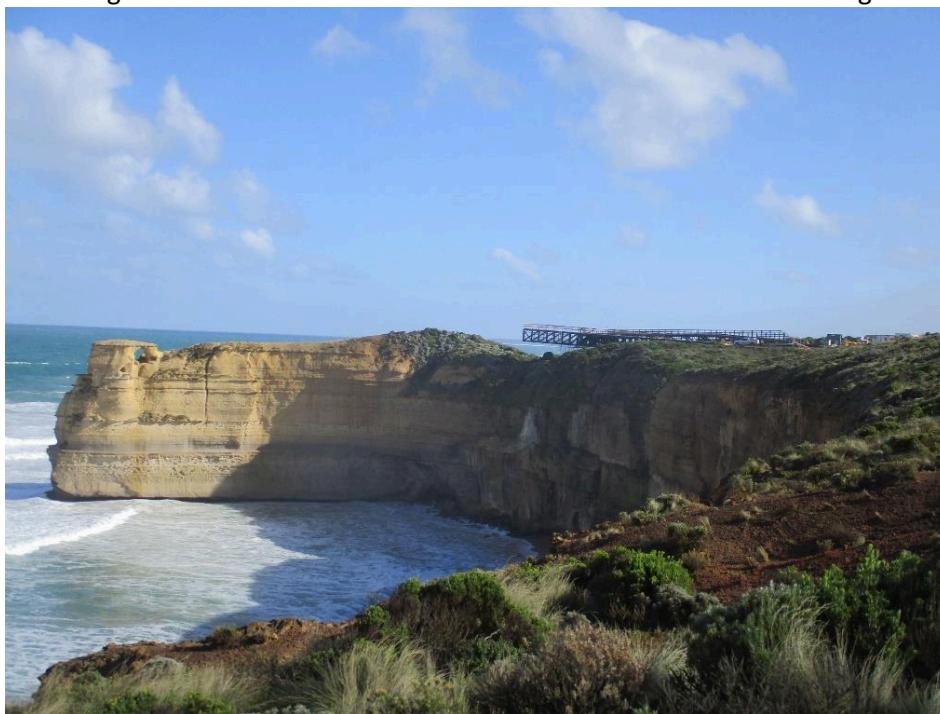
The 'diving board' style viewing platform at the 12 Apostles fails to take into account the nature of this coast. The limestone cliffs are riddled with lineations (sub-surface cracks), drainage channels, caverns, and sink holes. The image below shows the fragility of this narrow strip of cliff and 2 major surface drainage channels running alongside the east and west side of the development area.

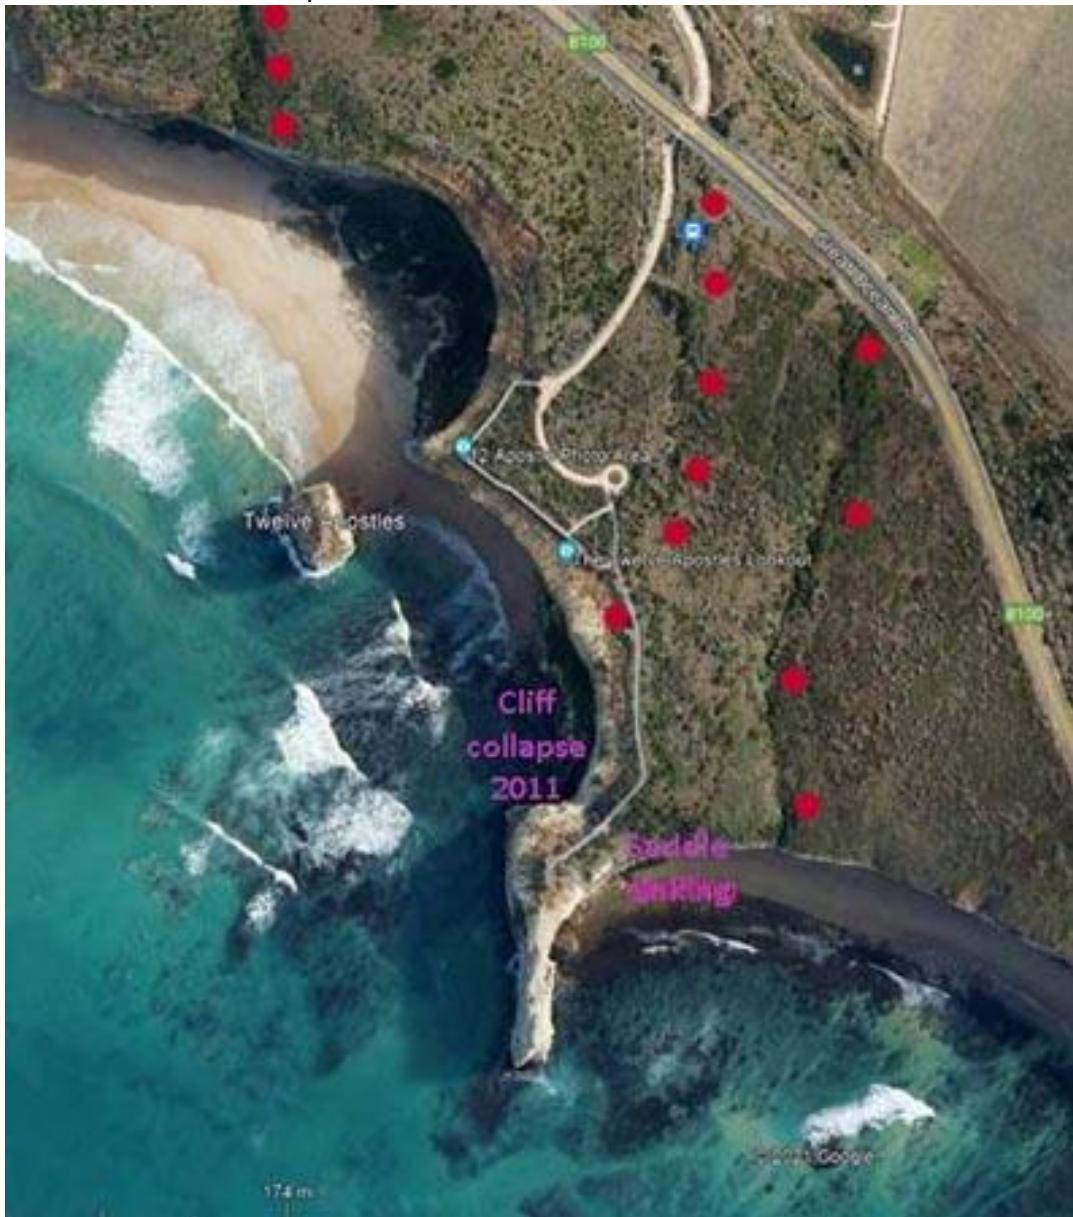
Photo: Google Earth. Red dots show drainage channels. The Saddle & the Castle Rock promontory is eroding

The 'Saddle', which the viewing platform will straddle, is eroding and in the process of forming an 'apostle'. The viewing area at the southern-most end of the promontory was closed. It is an area of geomorphological instability.

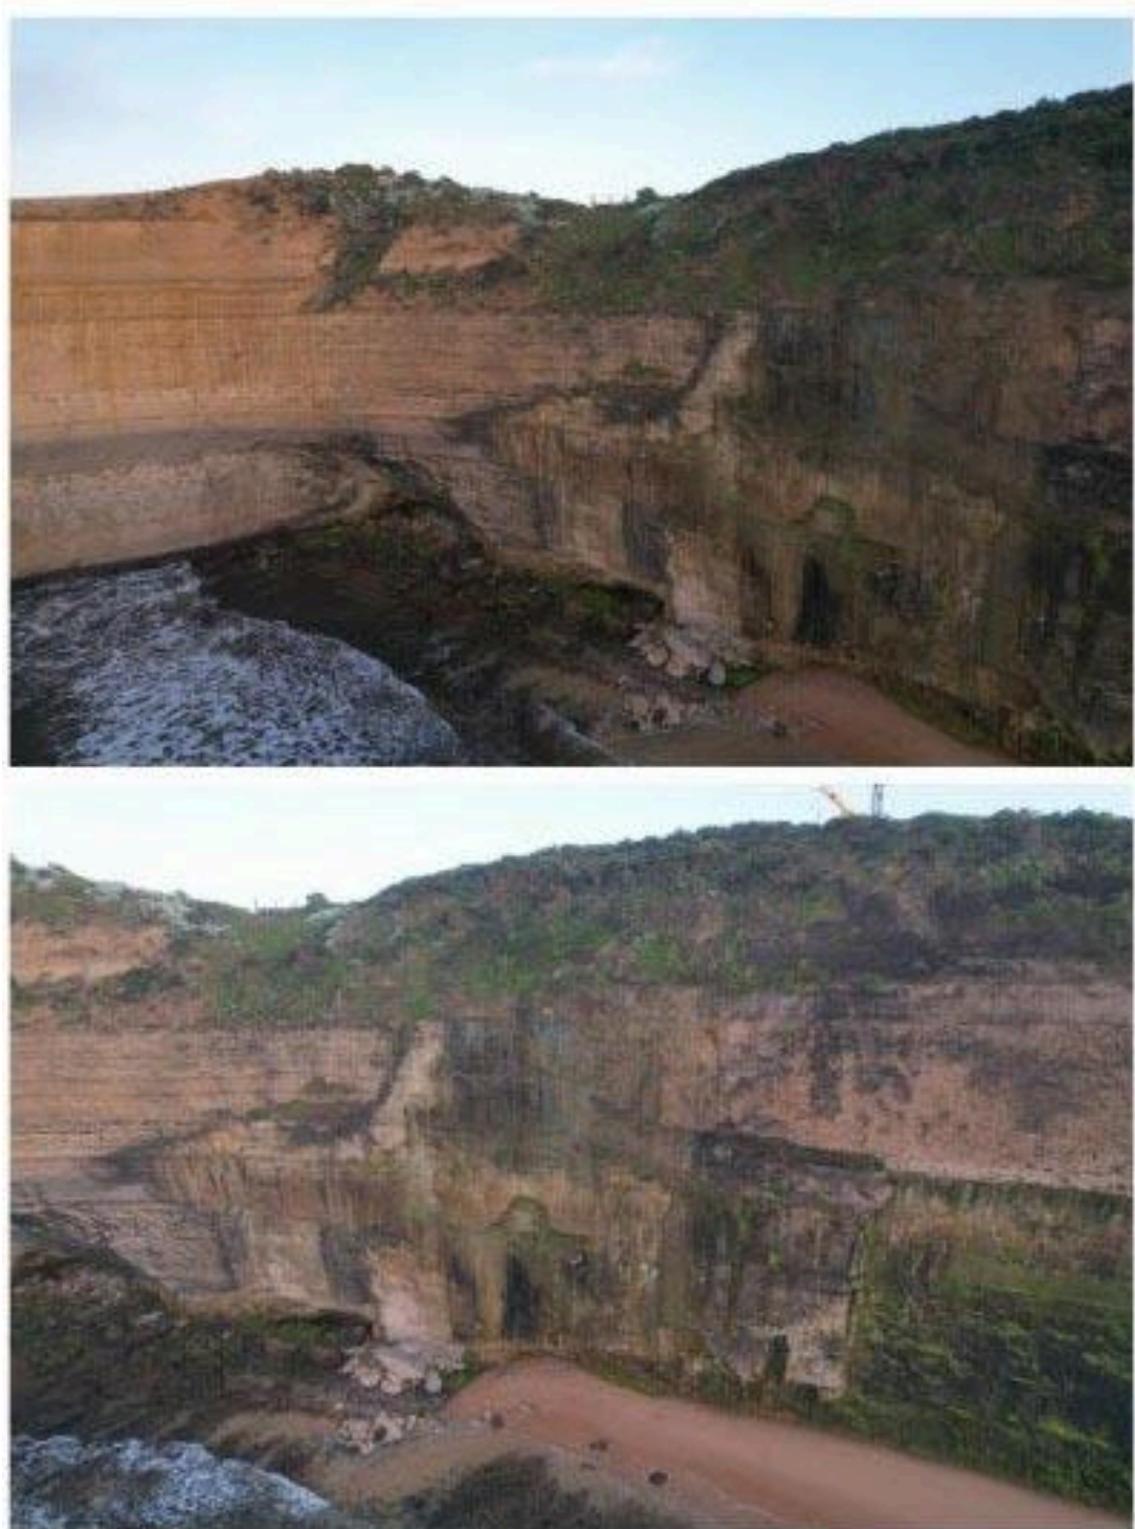
*Photos above: Parks Victoria – Annual Compliance Report (1 July 2021 to 30 June 2022) p.15*

Parks Vic photos (below) show a small cliff collapse on the eastern side while drilling, and there is undercutting (caverns and tunnel through to west side) beneath the viewing platform site.

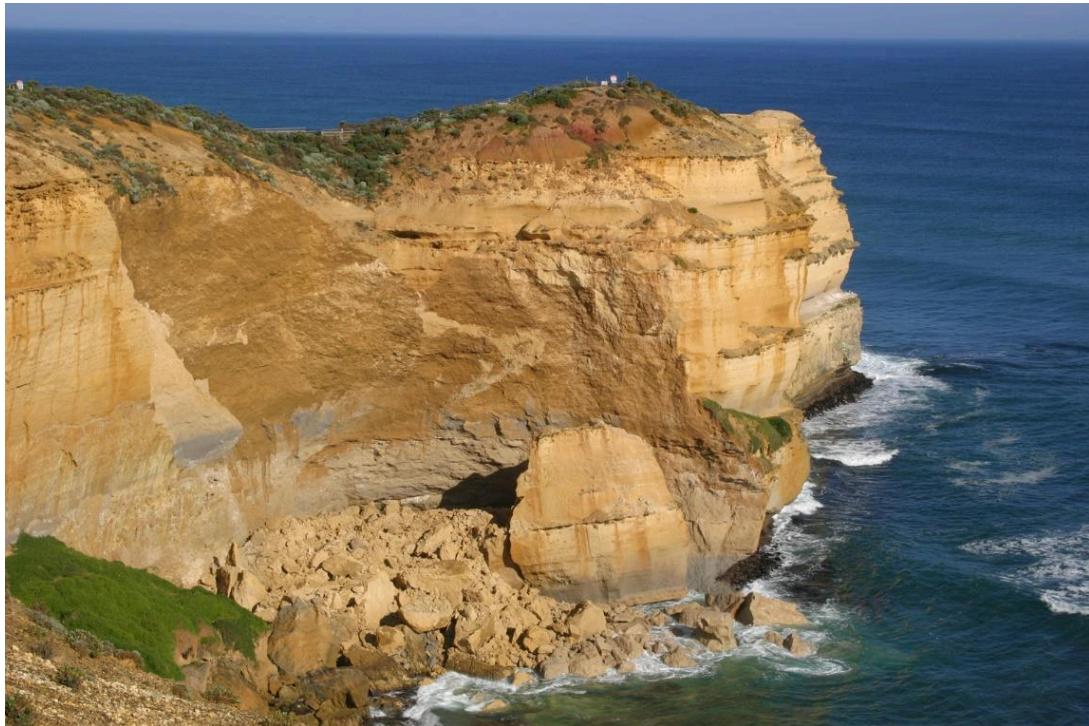
Photo PCCG Inc. 2011

**There was a major cliff collapse on the west side of the 'Saddle' in 2011 - below. The diving board viewing platform sits above this collapse with a cantilever structure extending over the cliff edge.**

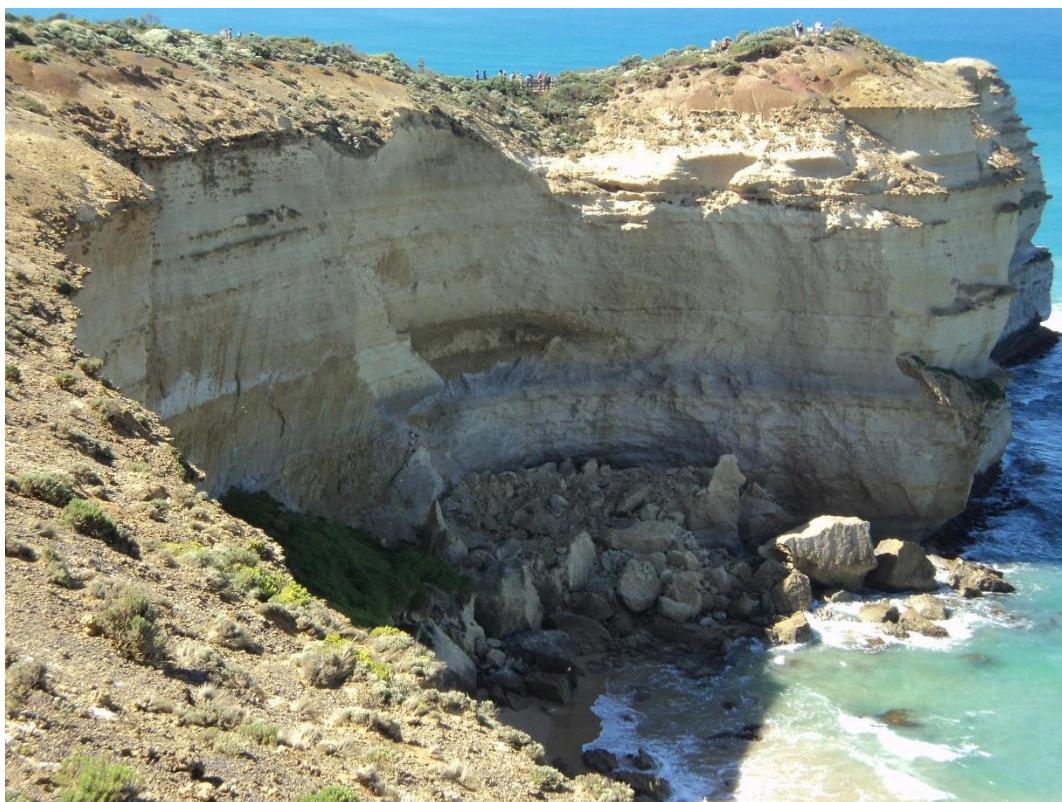
Castle Rock and the Saddle were still open to tourists 14-1-2014 despite the 2011 cliff collapse beneath walking track. Photo: PCCG Inc.

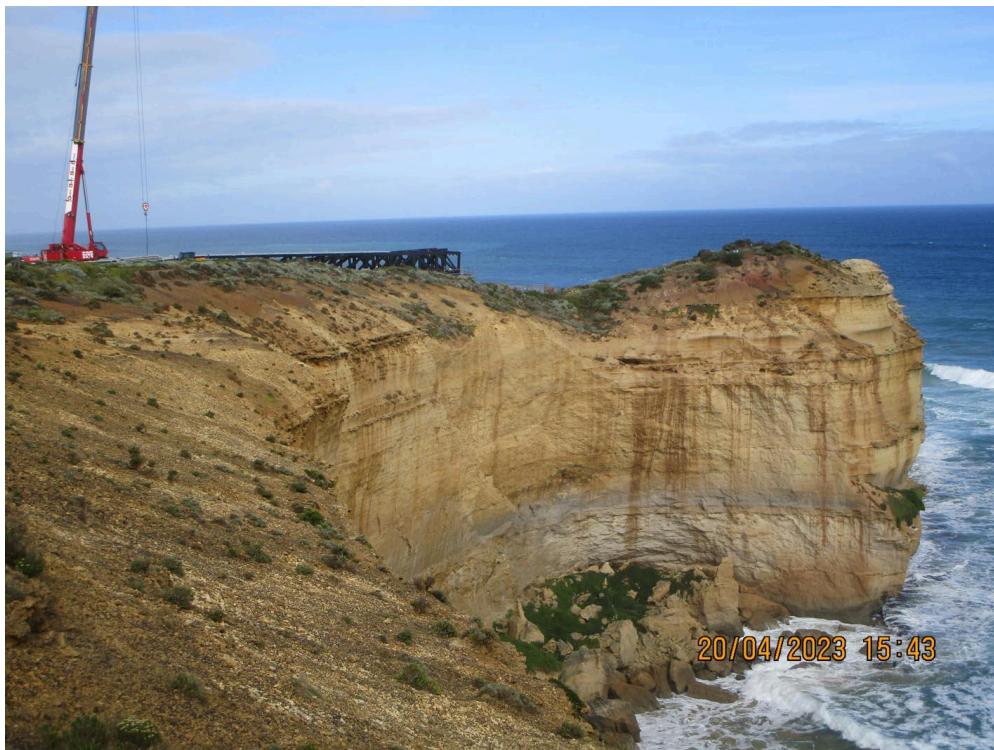
20-4-2023 – the base of the viewing platform is in place adjoining cliff collapses on both sides. Photo PCCG Inc

**Geotechnical experts recommend not siting any major infrastructure near the fragile cliffs.**

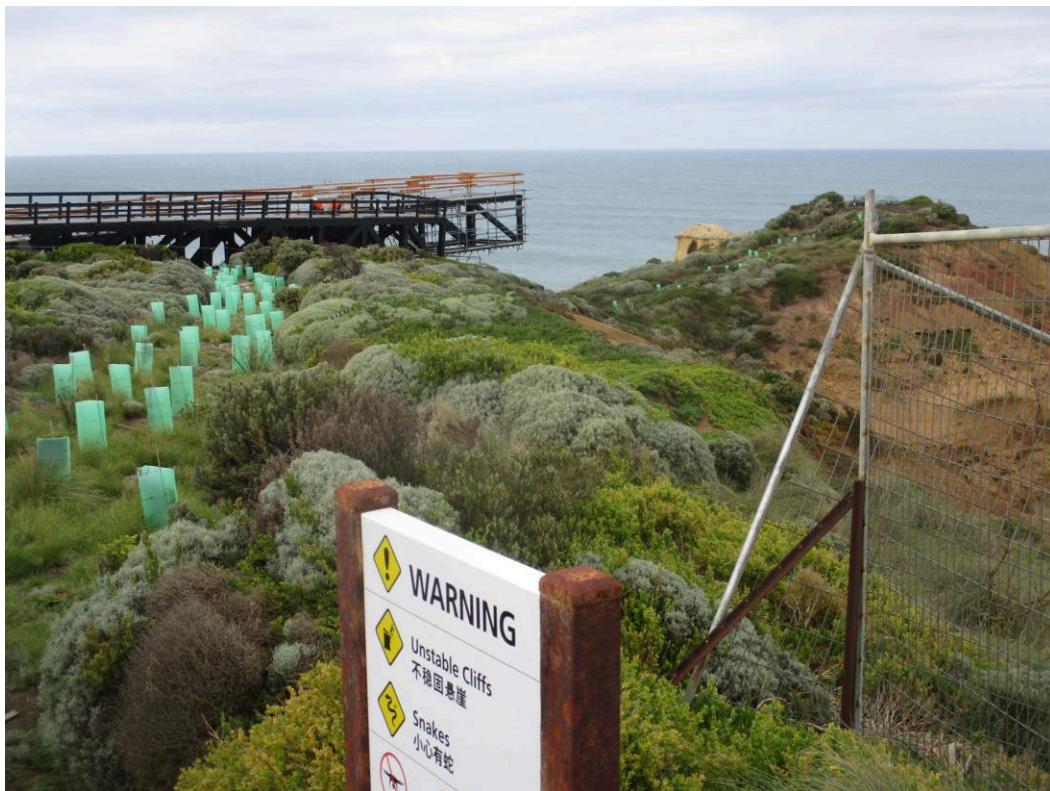
Parks Victoria sign warns the cliffs are unstable, yet the government continued building the viewing platform. Photo: PCCG Inc May 2023

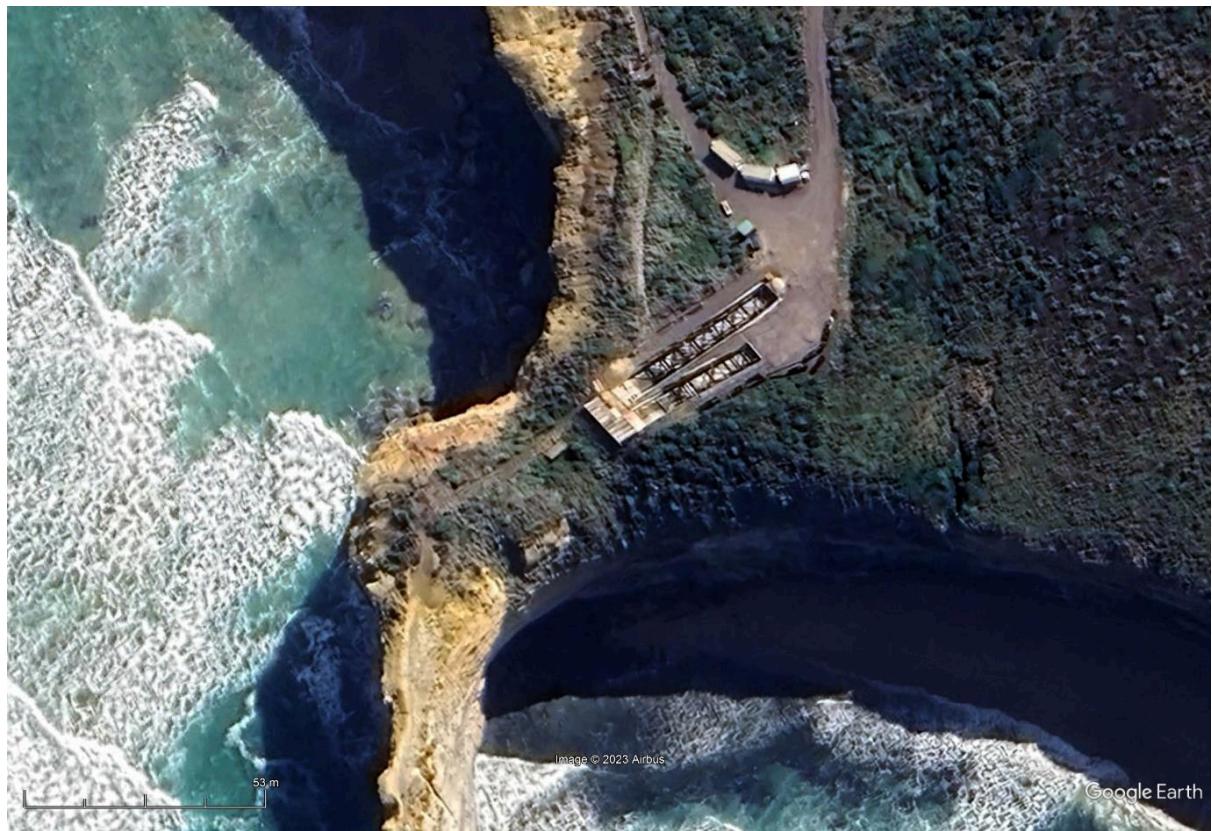
Google Earth 7/8/2023 – shows the start of foundations next to the 2011 cliff collapse and prior to the diving board being added.

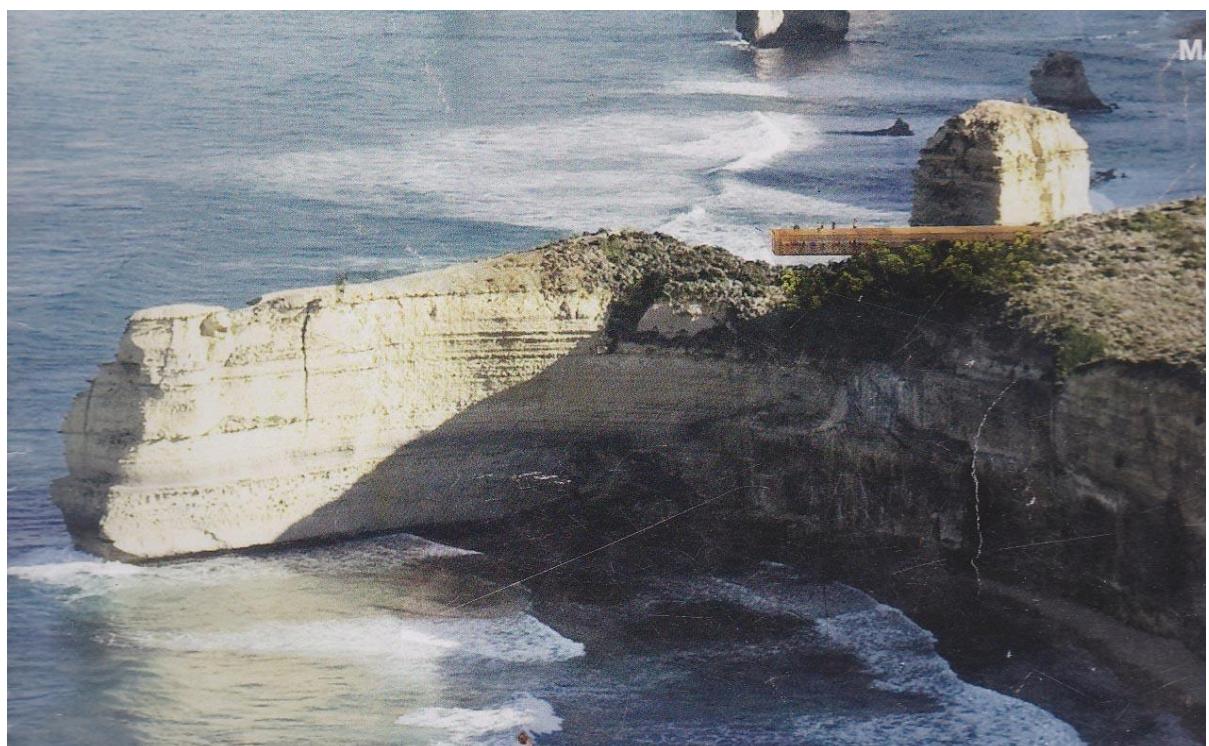
Cantilever structure – photo: Shipwreck Coast Master Plan. Parks Victoria 2015

**Parks Victoria states: “The design aims to remove visitors from the cliff edges and avoid breaches over the barriers”, but the viewing platform actually places visitors over the cliff edge.**

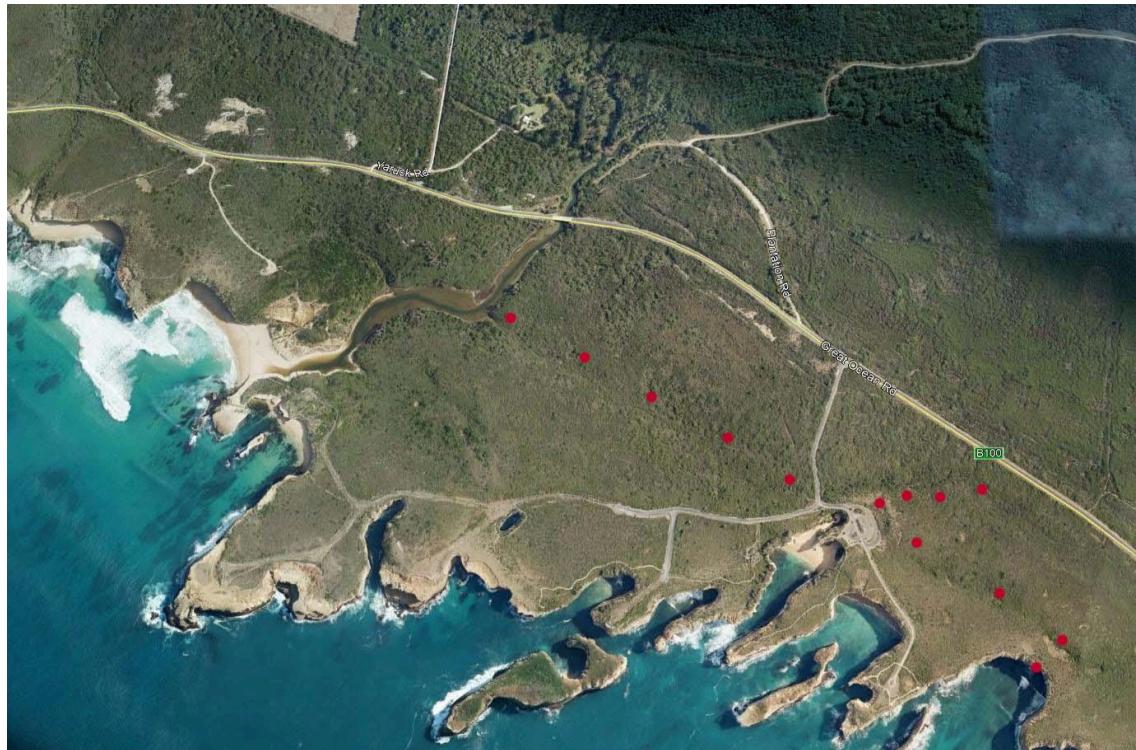
- When a major cavern and lineation system running from the Razorback cliff cavern under Loch Ard Gorge car park (where it intersects with other caverns and drainage lines) through to Sherbrooke River was raised with Parks Vic by the author, the government proposed moving the Loch Ard Gorge car park to the north side of the Great Ocean Road.  
(The author went into the Razorback cavern by boat. The cavern turns at a right angle towards Loch Ard Gorge. Aerial photos show the lineation runs through to Sherbrooke River. At Loch Ard Gorge there is another major cavern running north to south under the intersection road. Image below.)

Photo: Google Earth – red dots show underground caverns and lineations which run through to Sherbrooke River under the Loch Ard Gorge car park.

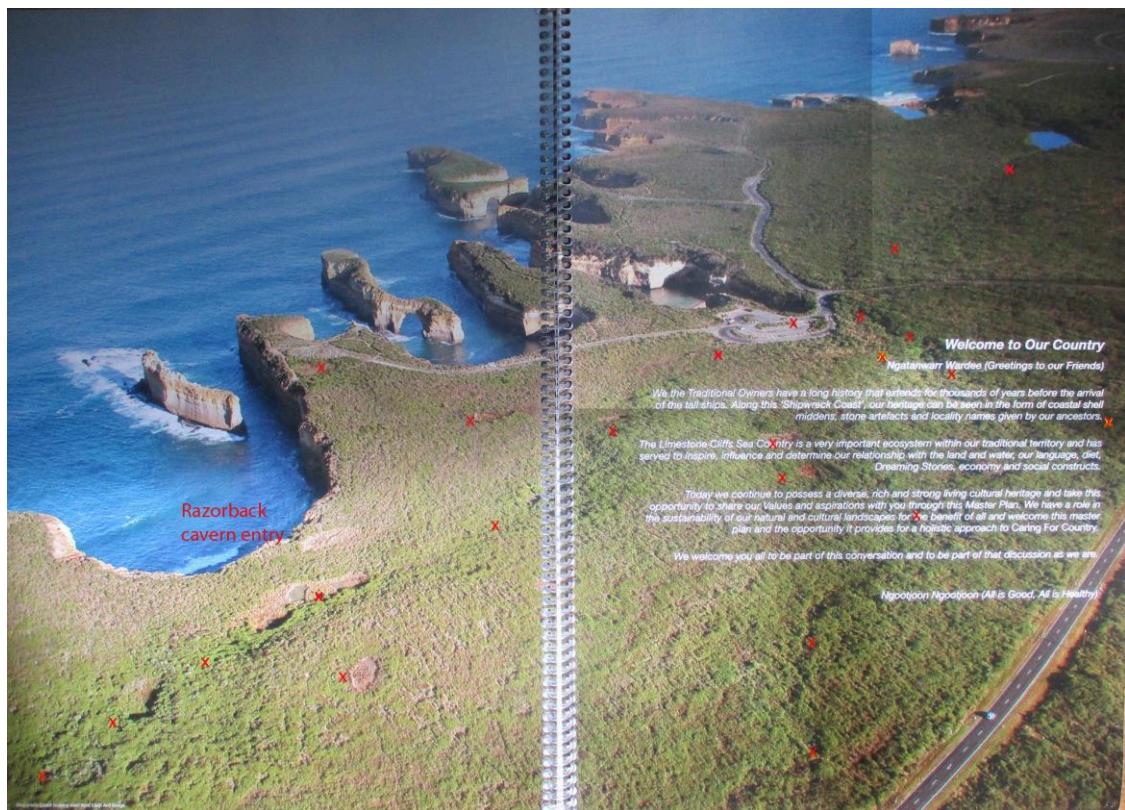
Photo: Shipwreck Coast Master Plan 2015 – red crosses added to show underground caverns and lineations

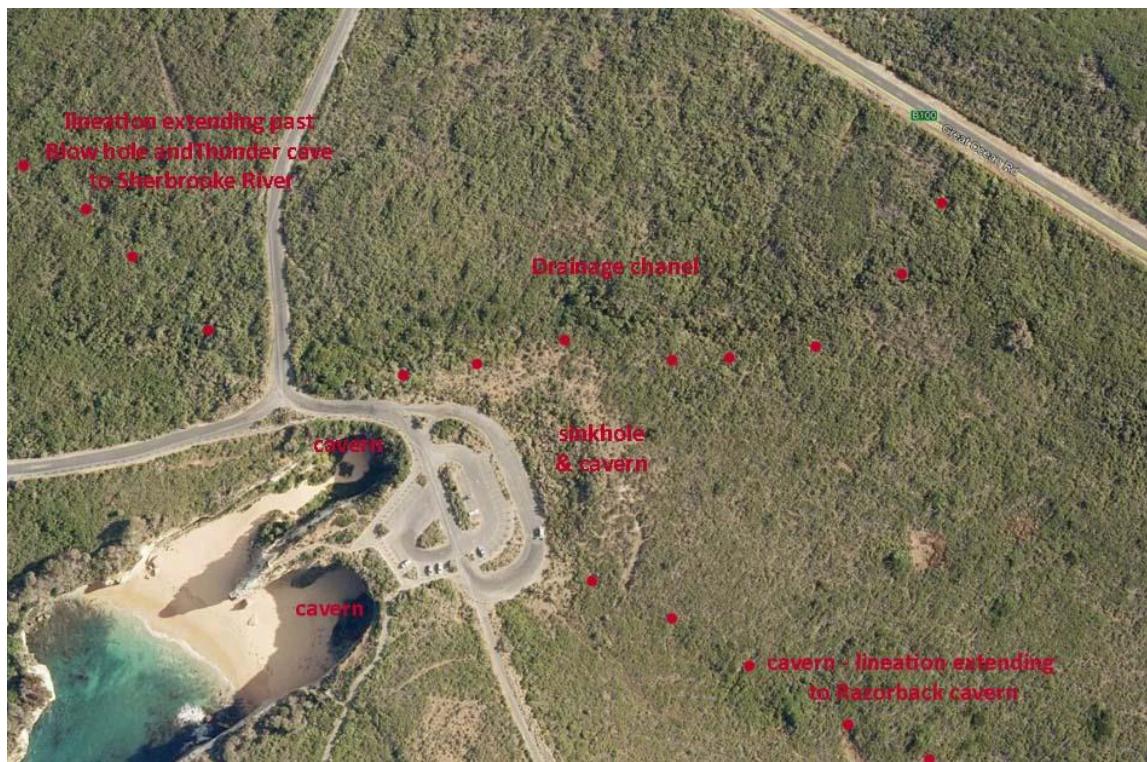
Photo: Google Earth – above – Loch Ard Gorge - red dots show lineations and drainage channels

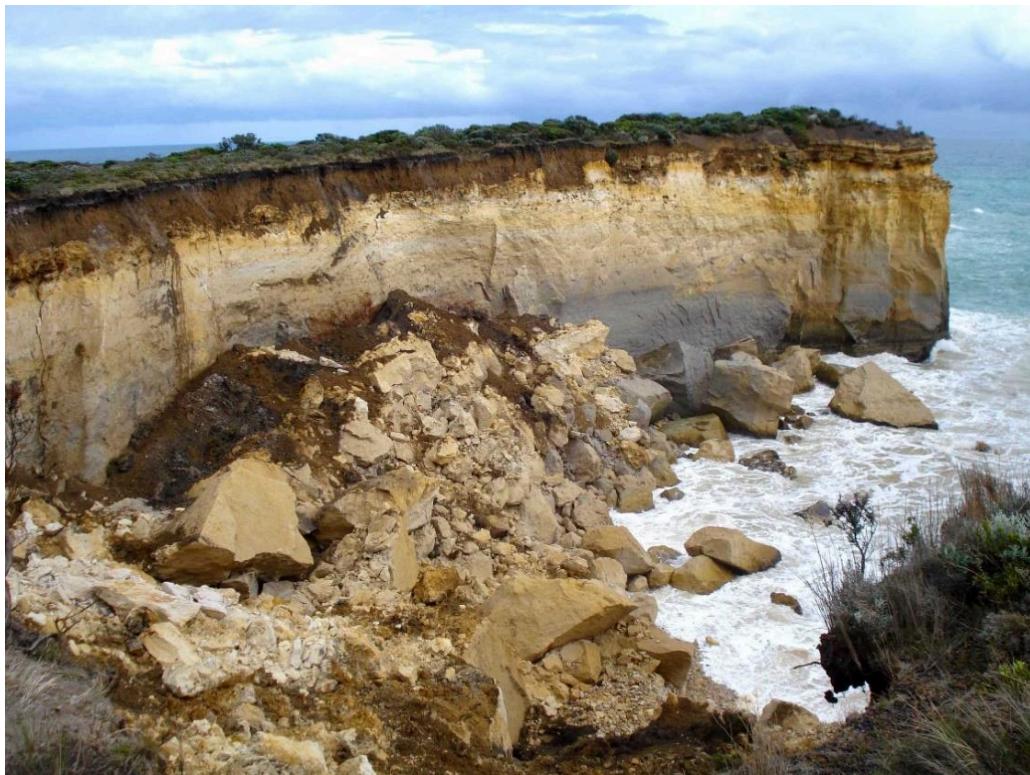
The Great Ocean Road was moved inland at the 'Murphies' just west of London Bridge (below). Many tons of rock collapsed catastrophically and without warning. This scenario could happen to the narrow peninsula at the 12 Apostles where the platform is built.

The 'Murphies' cliff collapse. Photo: PCCG Inc. 2010. Recent collapses have occurred at the Murphies.

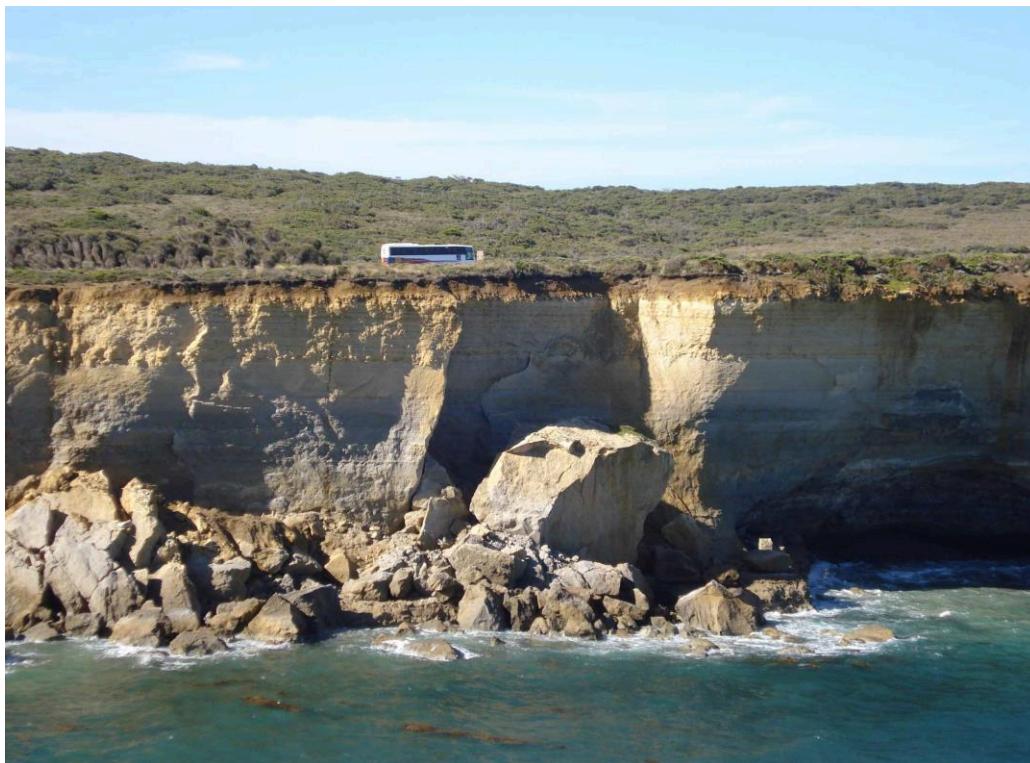
Cliff Collapse near Lace Curtains west of The Arch. Photo: PCCG Inc 2015

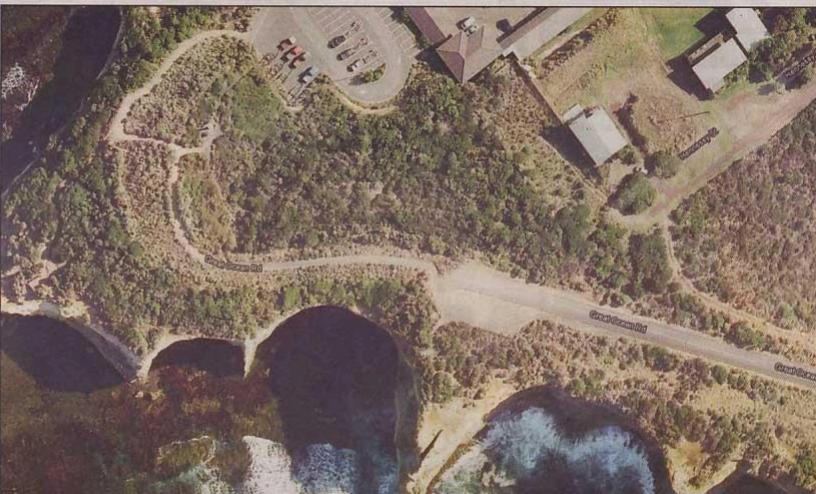
Lives at risk: The Corangamite Shire has announced the closure of a popular walking track on Sturgess Point, Port Campbell. A large sea cavern beneath the path has forced the closure. 2011

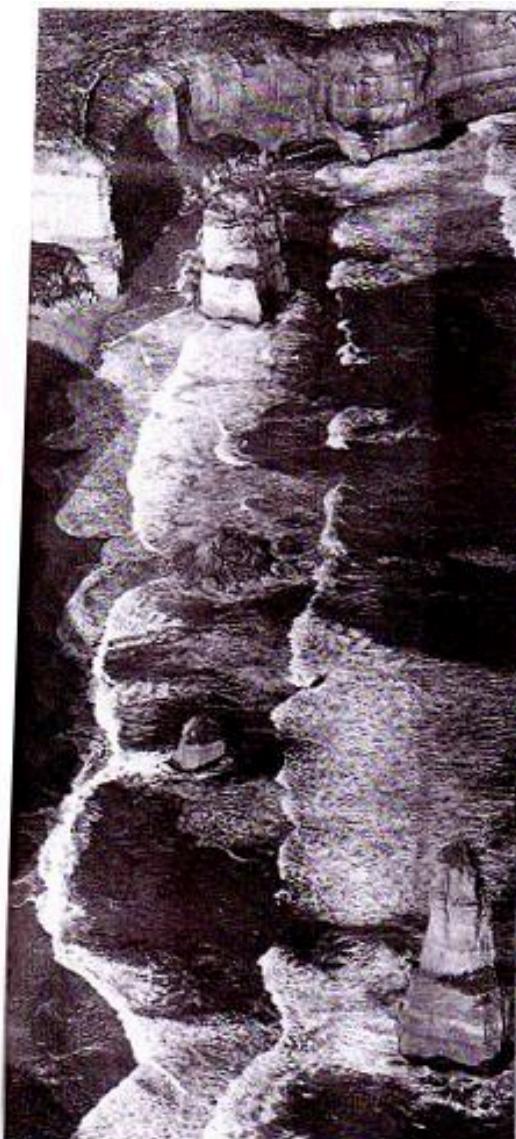
### HOW THE APOSTLES WERE FORMED

Dr Eric Bird's diagram below demonstrates the process occurring on these headlands. It is also occurring at the 12 Apostles lookout.

**Prowntomy**  
Water erodes and undercutts less-resistant rock along the flanks.

**Prowntomy/Arch**  
Continued erosion eventually forms a natural arch under the prowntomy.

**Arch**  
Collapse of the inner arch separates the outer arch.

**Apostle**  
Further erosion of the formation causes the collapse of the arch into rockpools.

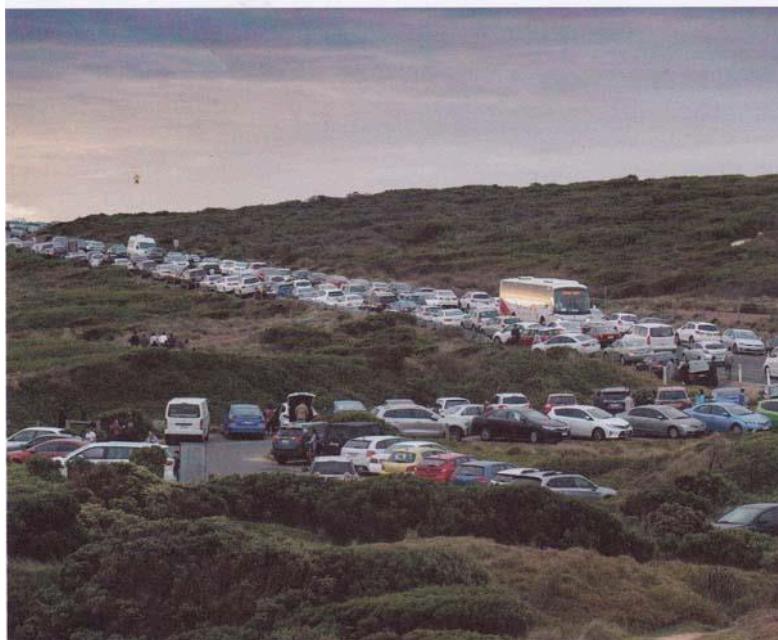
Capacity and safety issues plague the existing  
Twelve Apostles visitor precinct

Guard rails could have been put in place to stop people climbing onto the cliff edge at the current viewing platform.

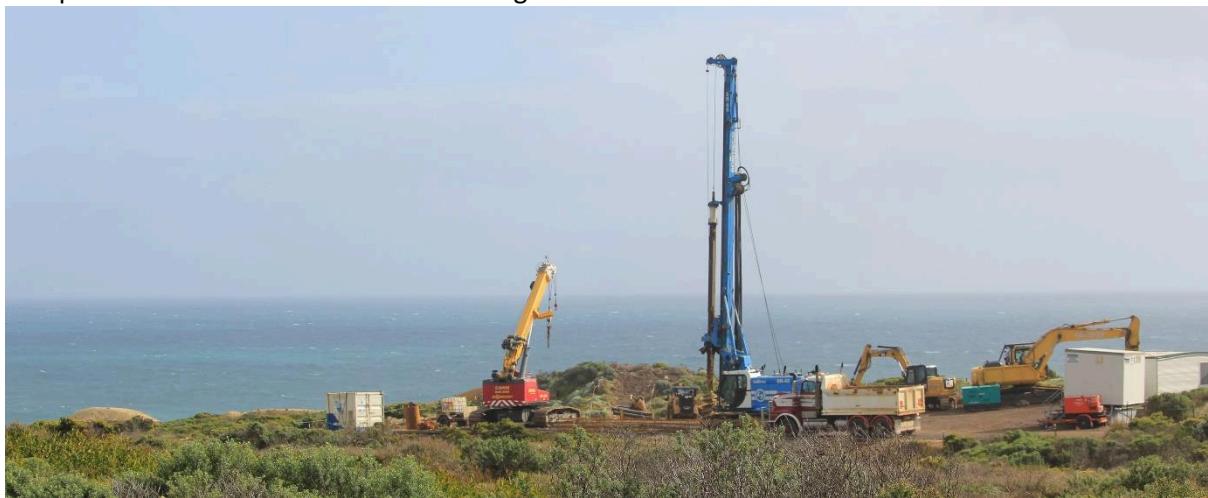
Photo 2021

12 Apostles infrastructure works on the edge of the cliff - below

**The extensive infrastructure being carried out at the 12 Apostles cliff edge – roadways, drilling or and anchoring foundations – will weaken an already fragile area and accelerate cliff collapse.**

- Until an open and inclusive EES was conducted;
- Any geotechnical reports for the viewing platform must be made public to allow full scrutiny and risk assessment.

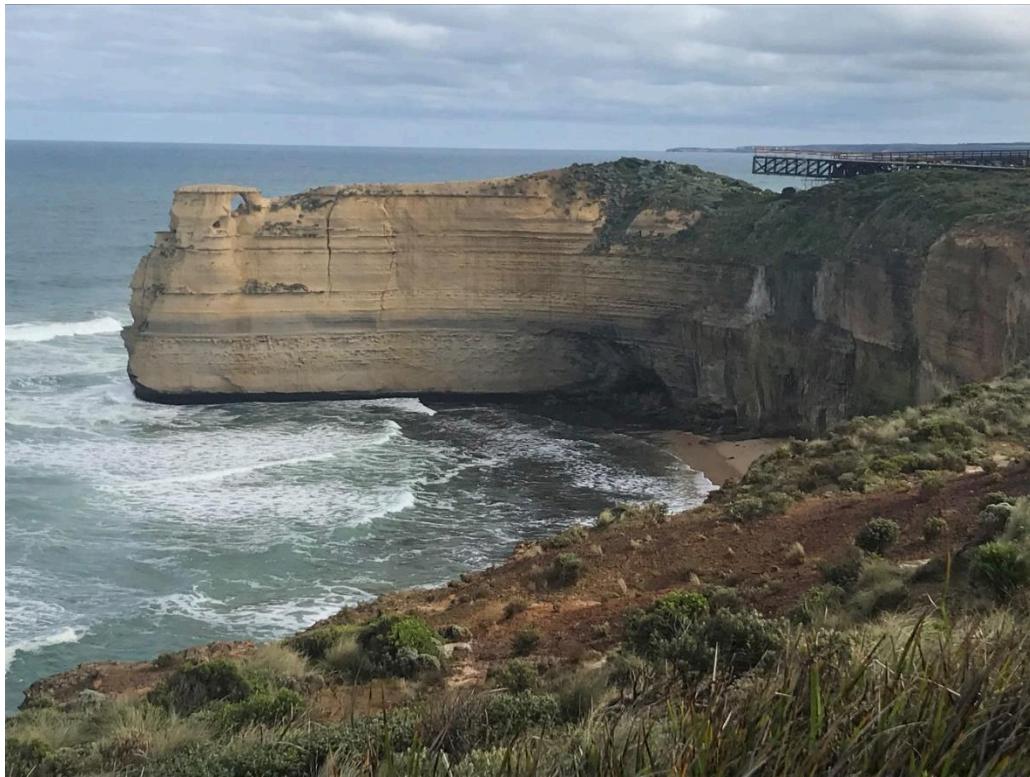
The diving board May 2023. Note cliff undercutting and sea attack erosion.

**Infrastructure works should not have occurred:**
