The Blowhole Viewing Platform, Port Campbell Coast

The Port Campbell Community Group Inc. is deeply concerned at the unsympathetic design and negative environmental impacts of the Blowhole viewing platform, again going ahead without community consultation.

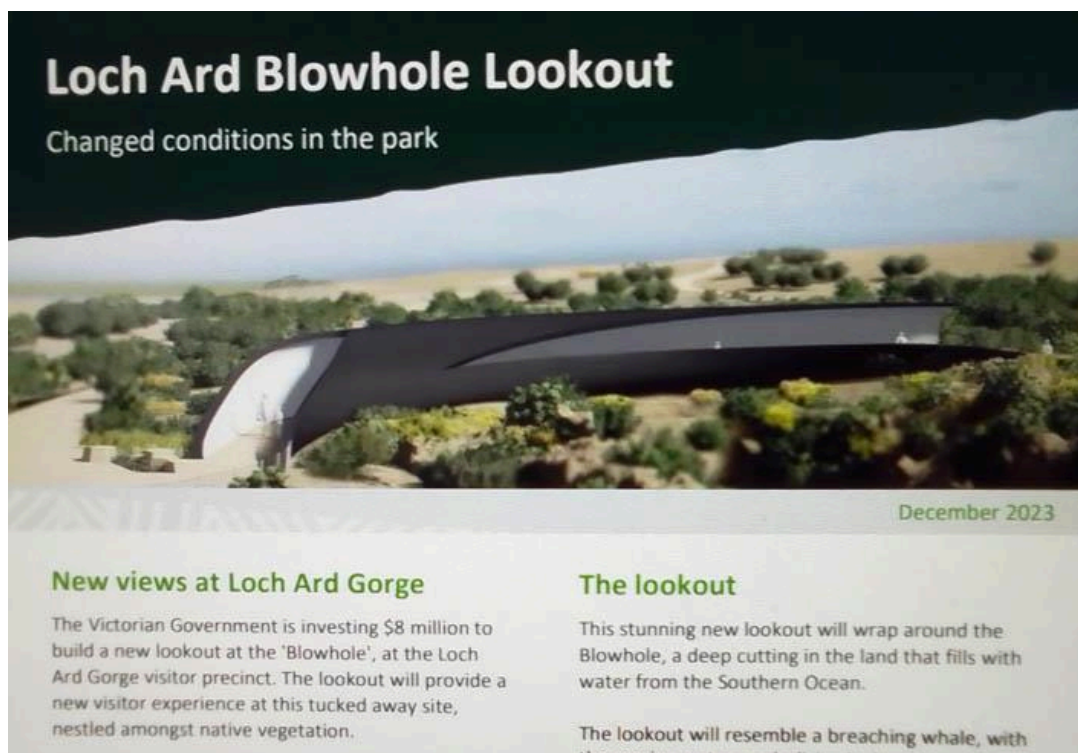
The enormous polycarbonate design, a black tube, is a blight on the natural landscape and will become a wind tunnel in this extreme environment, and it could collapse the cavity beneath.

The design (above) is far different to that shown in the Shipwreck Coast Master Plan (SCMP) which was shown to the community and which had low visual and environmental impact (below).

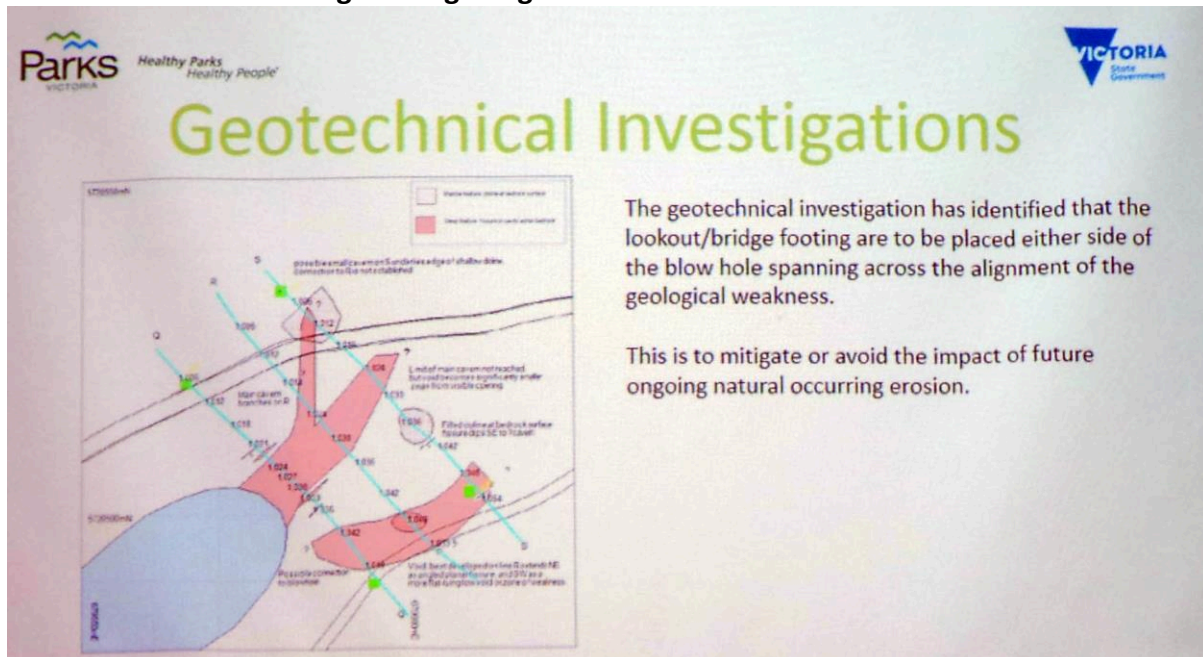
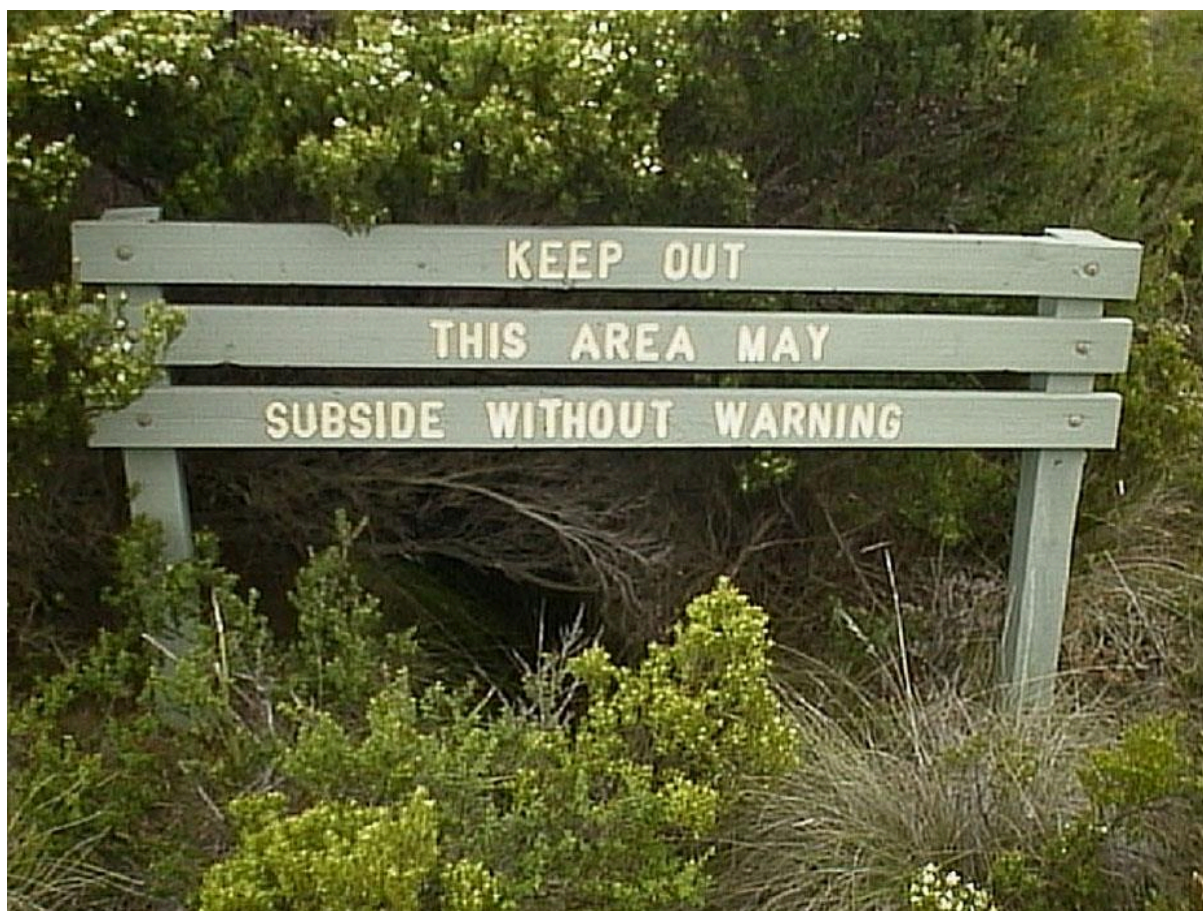
Photo PCCG Inc. Blowhole sign, c 2000

A Parks Victoria information session 31-8-2017 at Port Campbell showed a geotechnical plan (below) which coincides with the SCMP design where the bridging design would go straight across the Blowhole and little or no requirement for masses of concrete over a cavern – the area of recognised “geological weakness”.

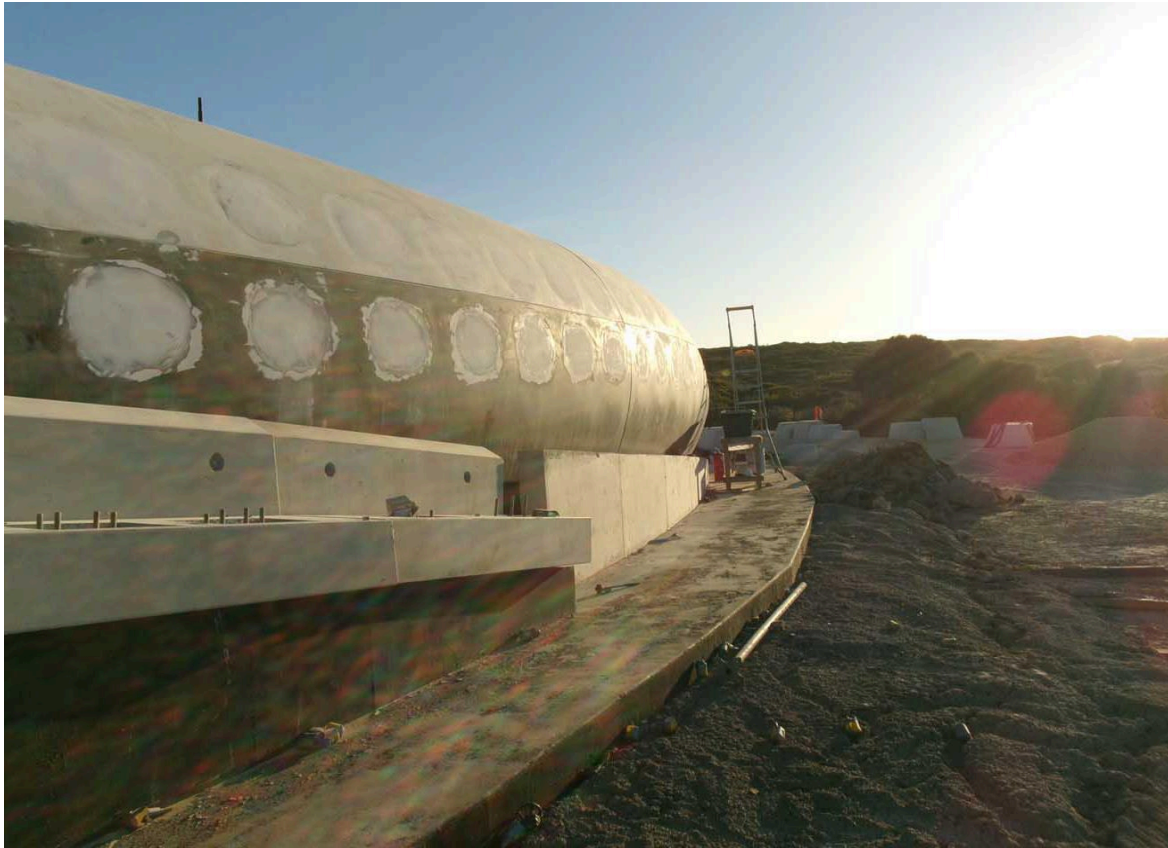
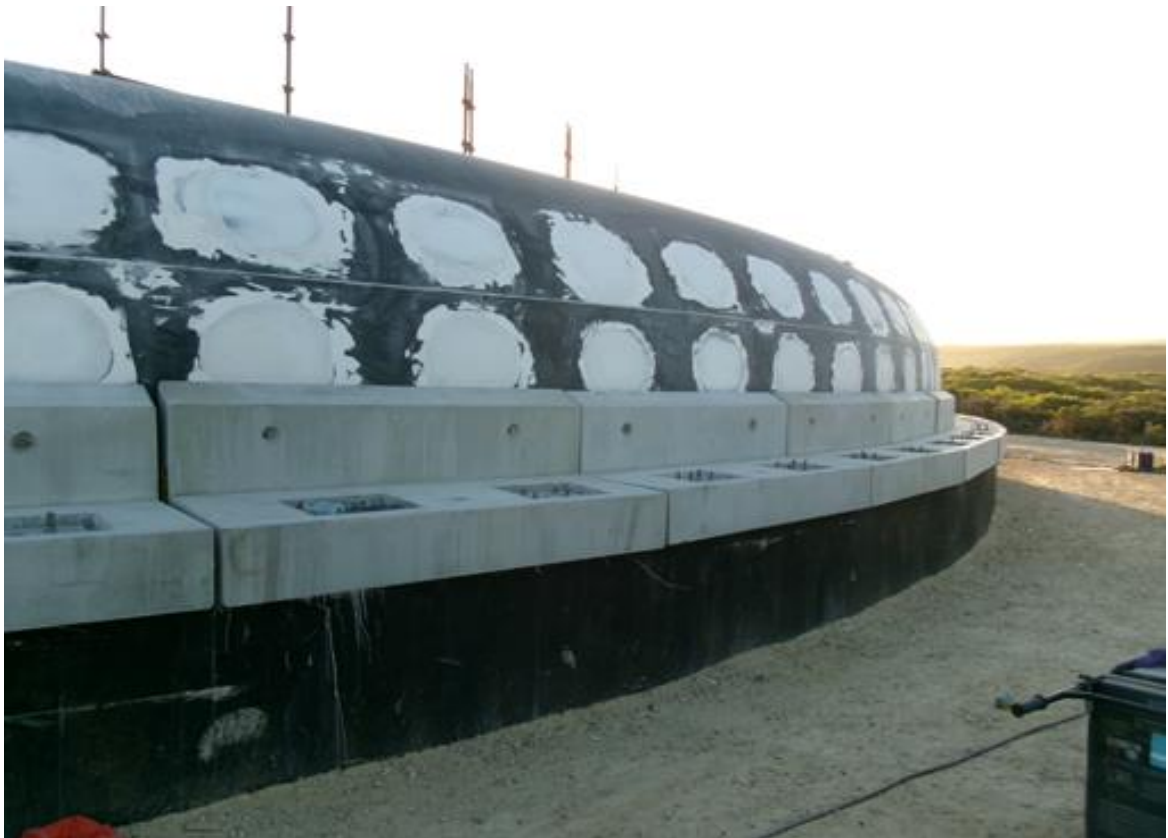
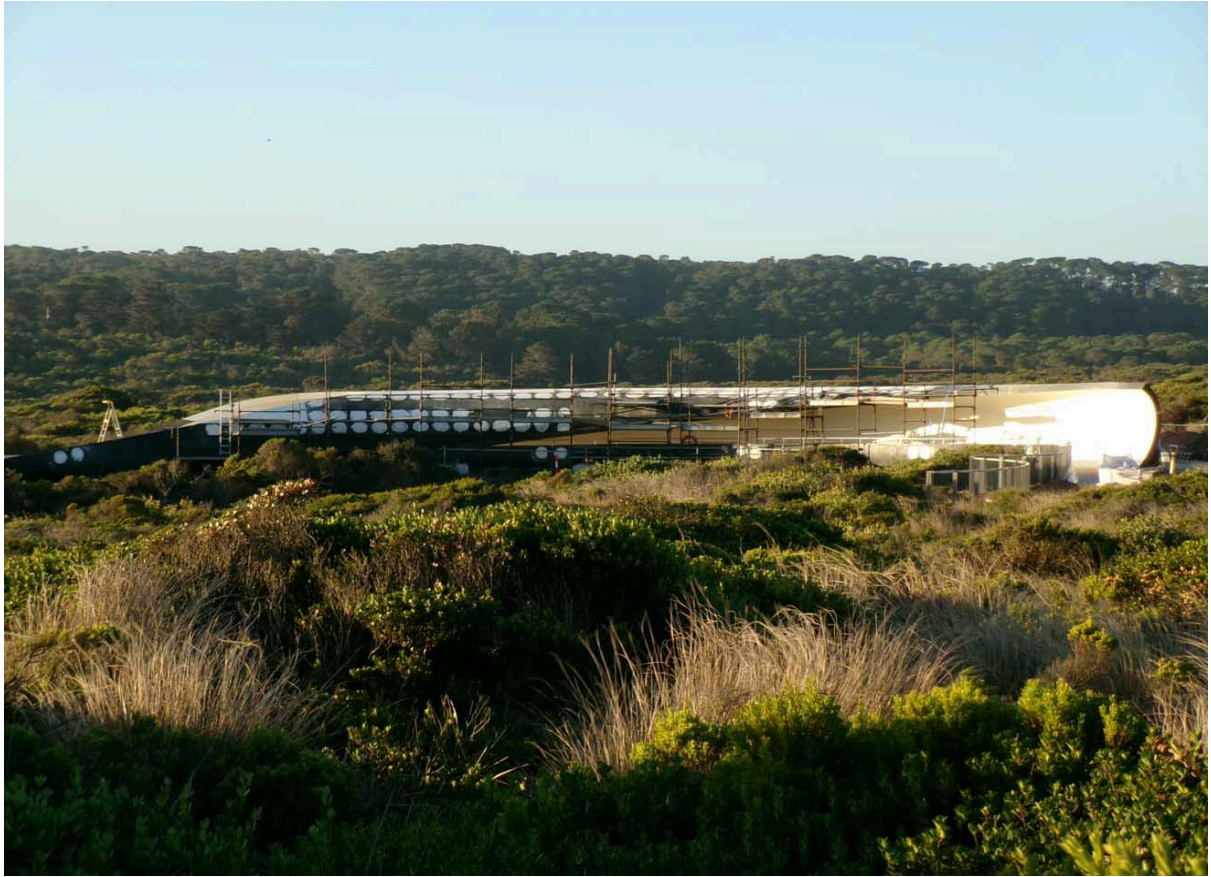
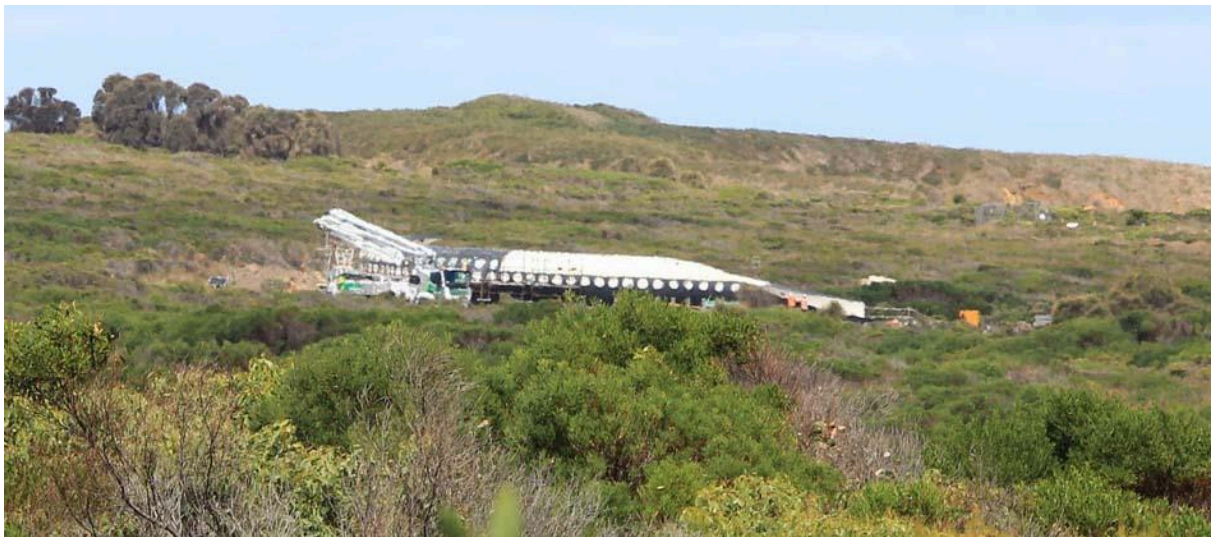
Photos: Port Campbell Community Group Inc. 27-2-2025

The design – below - looks like a crashed airliner

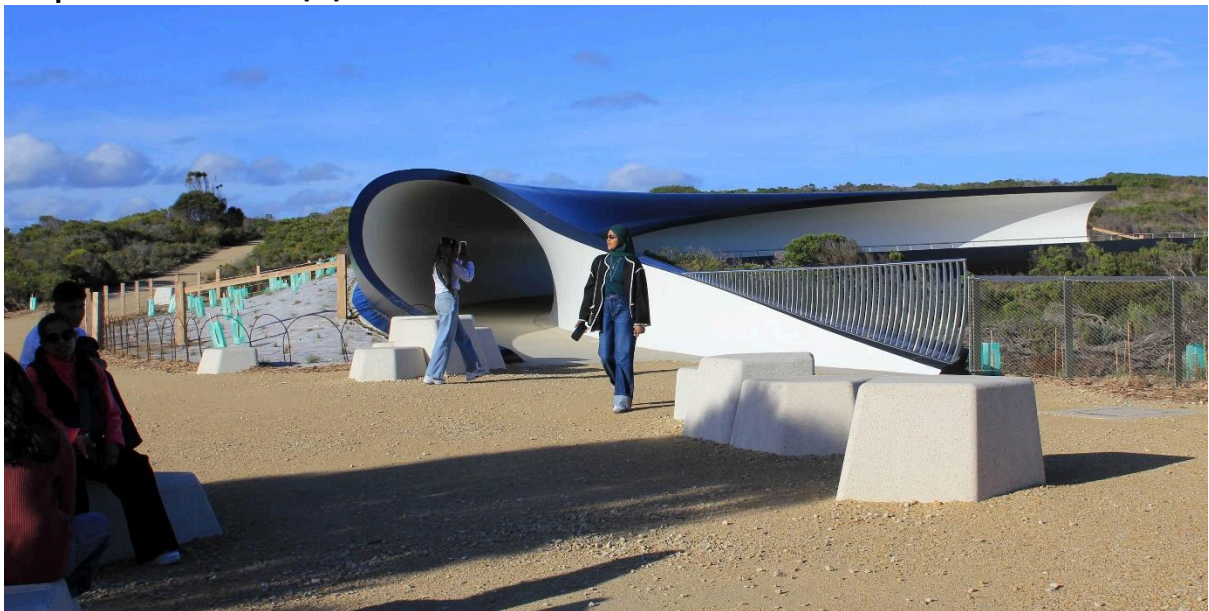
20/7/2025

It seems the polycarbonate tube has flexed as the 'portholes' appear to have cracked and are painted in white. 8/8/2025
